**Flood Control Project Maintenance
Levee Inspections**

Maintenance Issue Types Only, Levee Inspection Report By Mile - Spring 2016

Reclamation District No. 1600 Mull

Waterway	Bank	Unit Miles	Inspection Start/End	Inspector
Unit No. 01 Sacramento River	Right	10.46	03/24/2016 03/24/2016	Jai Lor

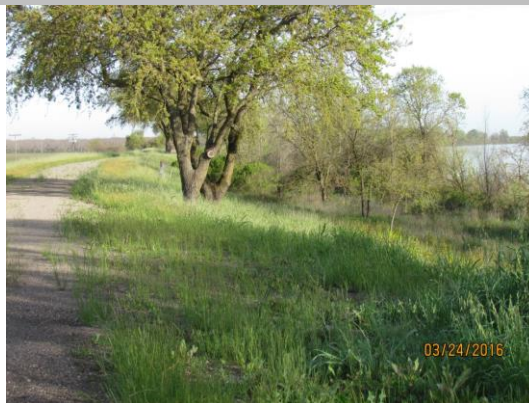
Photo 1 of 1 : SP_2016_RD1600_191_36_20160407_00098.jpg

LM Start	0.11	Rating **	M	Issue No.	36
LM End	10.45	Issue Type +	Ma	Location *	WS
Category	Earthen Levee			GPS Latitude/Longitude	
				Start	End
Item	Vegetation			38.676588 °	38.765423 °
				-121.631297 °	-121.635007 °
DWR ID	DWR_RD1600_01_f_2015_36				
Comment Code					
V1 : Control annual grass and weeds on the levee slopes and easements.					
Inspector Comment

View of the vegetation on the waterward side of the levee looking upstream. Spring 2016.

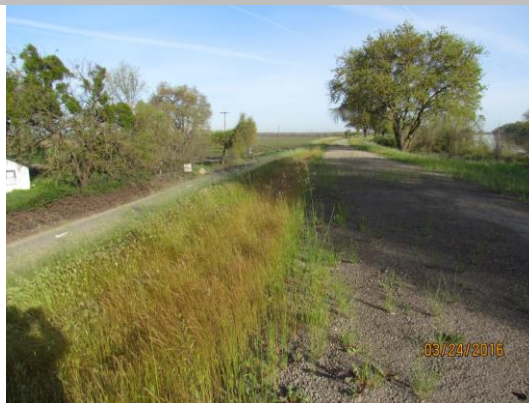
Photo 1 of 1 : SP_2016_RD1600_191_26_20160407_00097.jpg

LM Start	0.11	Rating **	M	Issue No.	26	
LM End	10.45	Issue Type +	Ma	Location *	LS	
Category	Earthen Levee			GPS Latitude/Longitude		
				Start		End
Item	Vegetation			38.676594 °		38.765422 °
				-121.631295 °		-121.635009 °
DWR ID	DWR_RD1600_01_s_2016_26					
Comment Code						
V1 : Control annual grass and weeds on the levee slopes and easements.						
Inspector Comment

View of the vegetation on the landward side of the levee looking upstream. Spring 2016.

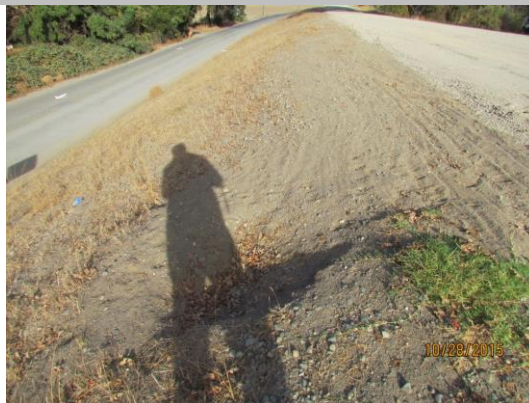
Photo 1 of 1 : SP_2016_RD1600_191_38_20160304_00033.jpg

LM Start	0.12	Rating **	M	Issue No.	38
LM End	0.12	Issue Type +	Ma	Location *	LS
Category	Earthen Levee			GPS Latitude/Longitude	
				Start	End
Item	Slope Stability			38.676654 °	38.676654 °
				-121.631348 °	-121.631348 °
DWR ID	DWR_RD1600_01_f_2015_38				
Comment Code					
S3 : Repair the levee slope damaged by vehicle traffic and prevent access where possible.					
Inspector Comment

View of a slope depression on the landward side of the levee looking downstream. Fall 2015.

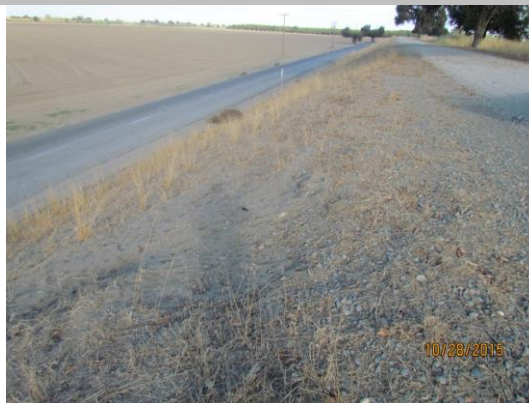
Photo 1 of 1 : SP_2016_RD1600_191_39_20160304_00034.jpg

LM Start	0.21	Rating **	M	Issue No.	39
LM End	0.21	Issue Type +	Ma	Location *	LS
Category	Earthen Levee			GPS Latitude/Longitude	
				Start	End
Item	Slope Stability			38.677766 °	38.677766 °
				-121.632123 °	-121.632123 °
DWR ID	DWR_RD1600_01_f_2015_39				
Comment Code					
S2 : Repair the levee slope damaged by foot traffic and prevent access where possible.					
Inspector Comment

View of the slope stability on the landward side of the levee looking upstream. Fall 2015.

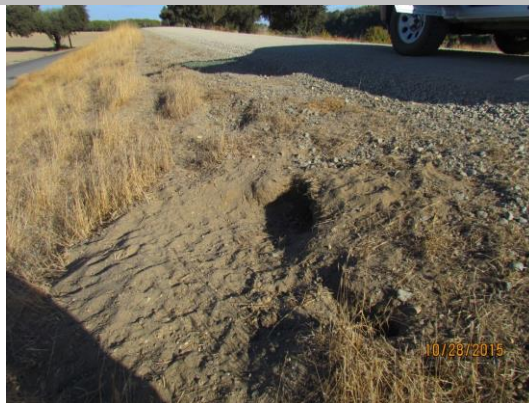
Photo 1 of 1 : SP_2016_RD1600_191_40_20160304_00035.jpg

View of the rodent hole on the landward side of the levee looking upstream. Fall 2015.

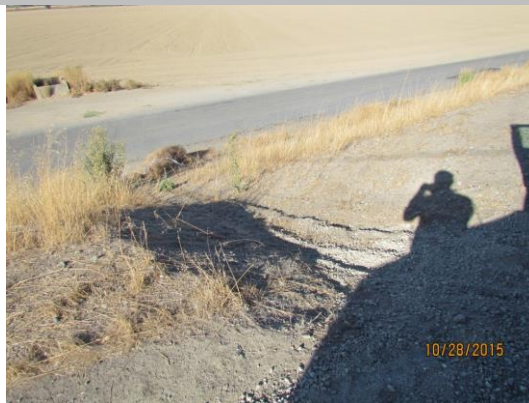
Photo 1 of 1 : SP_2016_RD1600_191_133_20160304_00055.jpg

LM Start	0.53	Rating **	M	Issue No.	133	
LM End	0.53	Issue Type +	Ma	Location *	LS	
Category	Earthen Levee			GPS Latitude/Longitude		
				Start		End
Item	Slope Stability			38.682140 °		38.682140 °
				-121.634083 °		-121.634083 °
DWR ID	DWR_RD1600_01_f_2013_133					
Comment Code						
S2 : Repair the levee slope damaged by foot traffic and prevent access where possible.						
Inspector Comment

View of the slope stability on the landward side of the levee. Fall 2015.

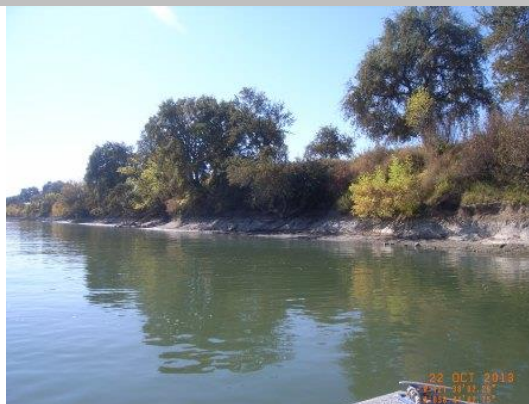
Photo 1 of 1 : SP_2016_RD1600_191_7_20160304_00009.jpg

LM Start	0.56	Rating **	M	Issue No.	7
LM End	0.66	Issue Type +	Ma	Location *	WS
Category	Supplemental			GPS Latitude/Longitude	
				Start	End
Item	2015 USACE Erosion Survey, DRAFT			38.682707 °	38.684106 °
				-121.633830 °	-121.634219 °
DWR ID	DWR_RD1600_01_s_2016_7				
Comment Code					
Inspector Comment					
2000 - Very cohesive vertical bank. 2003 - Some minor new erosion. 2006 - Some minor erosion in old pockets. 2009 - Minimal new erosion. 2011 - Multiple new erosion pockets and a few new tree popouts. 2015: No observed changes. [2015 Site ID: SAC_71-3_R]

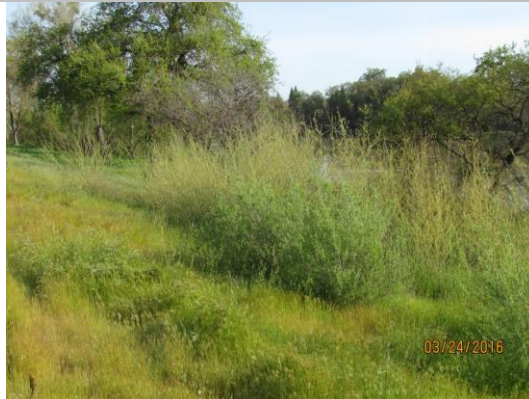
Photo 1 of 2 : SP_2016_RD1600_191_29_20160407_00101.jpg

LM Start	0.62	Rating **	M	Issue No.	29
LM End	0.62	Issue Type +	Ma	Location *	WS
Category	Earthen Levee			GPS Latitude/Longitude	
				Start	End
Item	Vegetation			38.683415 °	38.683415 °
				-121.634448 °	-121.634448 °
DWR ID	DWR_RD1600_01_s _ 2016_29				
Comment Code					
V2 : Remove the wild growth other than native grasses from the levee slopes.					
Inspector Comment					
Recommend removal of willow trees.

Perspective view of the willows on the waterward side of the levee looking upstream. Spring 2016.

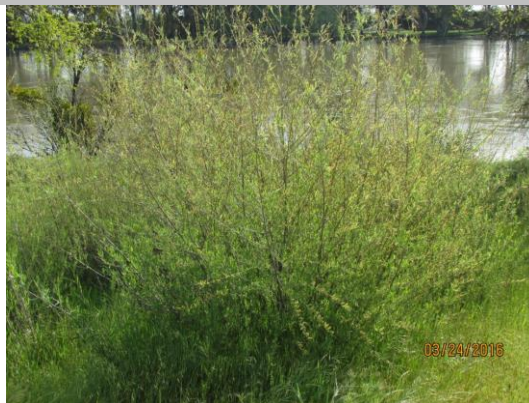
Photo 2 of 2 : SP_2016_RD1600_191_29_20160407_00103.jpg

Willows are growing on the waterward side of the levee. Spring 2016.

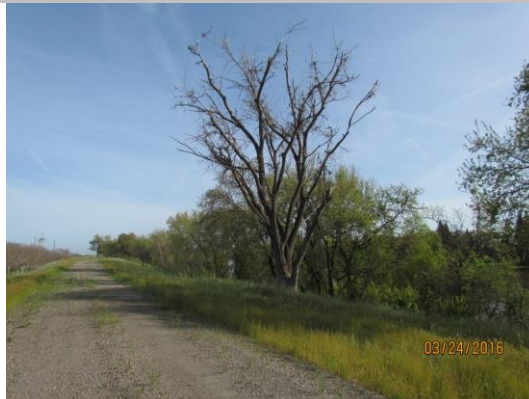
Photo 1 of 1 : SP_2016_RD1600_191_624_20160407_00104.jpg

View of the dying tree on the waterward side of the levee looking upstream. Spring 2016.

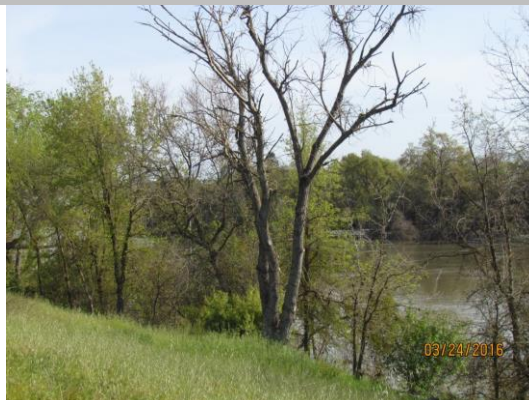
Photo 1 of 1 : SP_2016_RD1600_191_625_20160407_00105.jpg

LM Start	0.83	Rating **	A/W	Issue No.	625
LM End	0.83	Issue Type +	Ma	Location *	WS
Category	Earthen Levee			GPS Latitude/Longitude	
				Start	End
Item	Vegetation			38.686515 °	38.686515 °
				-121.635134 °	-121.635134 °
DWR ID	DWR_RD1600_01_s_2014_625				
Comment Code					
V7 : Trees / Woody Vegetation					
Inspector Comment					
The tree is dying and needs to be monitored so there is no threat to the levee

View of the tree on the waterward side of the levee. Spring 2016.

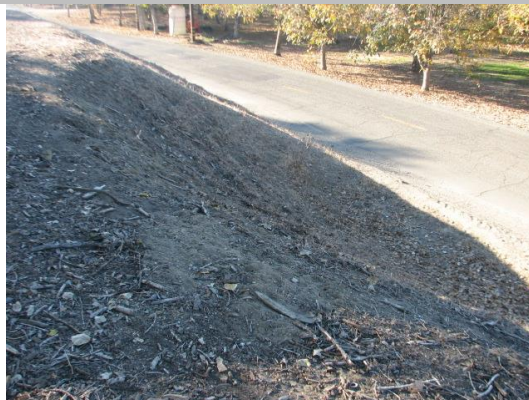
Photo 1 of 2 : SP_2016_RD1600_191_134_20160304_00056.jpg

LM Start	0.97	Rating **	M	Issue No.	134
LM End	0.97	Issue Type +	Ma	Location *	LS
Category	Earthen Levee			GPS Latitude/Longitude	
				Start	End
Item	Slope Stability			38.688454 °	38.688454 °
				-121.635528 °	-121.635528 °
DWR ID	DWR_RD1600_01_f_2013_134				
Comment Code					
S1 : Repair slope instability.					
Inspector Comment

The levee has a deep depression caused by slope stability. Fall 2013

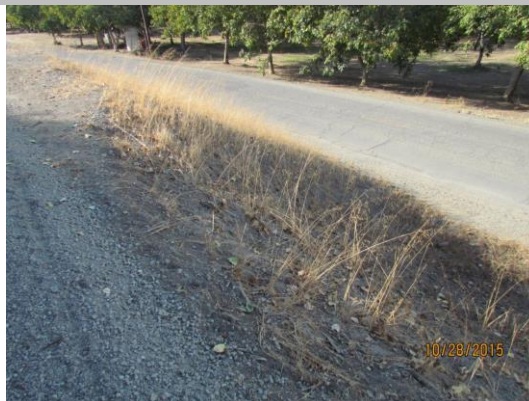
Photo 2 of 2 : SP_2016_RD1600_191_134_20160304_00057.jpg

LM Start	0.97	Rating **	M	Issue No.	134 (cont)	
LM End	0.97	Issue Type +	Ma	Location *	LS	
Category	Earthen Levee			GPS Latitude/Longitude		
				Start		End
Item	Slope Stability			38.688454 °		38.688454 °
				-121.635528 °		-121.635528 °
DWR ID	DWR_RD1600_01_f_2013_134					
Comment Code						
S1 : Repair slope instability.						
Inspector Comment

View of the depression of the slope on the landward side of the levee looking downstream. Fall 2015.

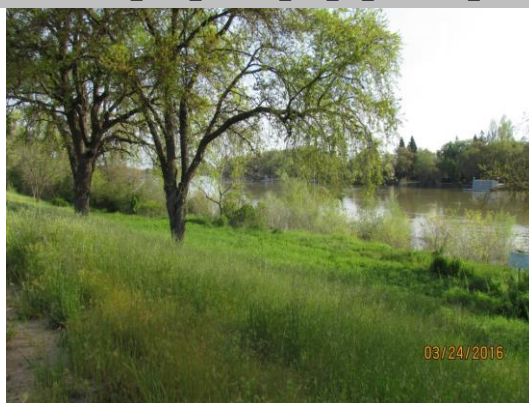
Photo 1 of 2 : SP_2016_RD1600_191_22_20160407_00108.jpg

LM Start	1.01	Rating **	A/W	Issue No.	22
LM End	1.10	Issue Type +	Ma	Location *	WS
Category	Earthen Levee			GPS Latitude/Longitude	
				Start	End
Item	Vegetation			38.689092 °	38.690368 °
				-121.635616 °	-121.635669 °
DWR ID	DWR_RD1600_01_s_2012_22				
Comment Code					
V8 : Environmental Requirements.					
Inspector Comment

View of the revegetation site at the berm edge on the waterward side of the levee looking upstream. Spring 2016.

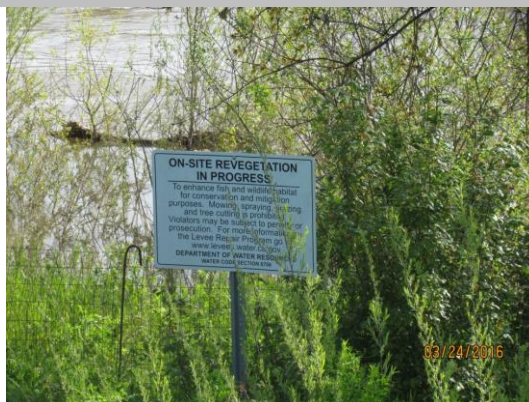
Photo 2 of 2 : SP_2016_RD1600_191_22_20160407_00107.jpg

Sign stating revegetation site. Spring 2016.

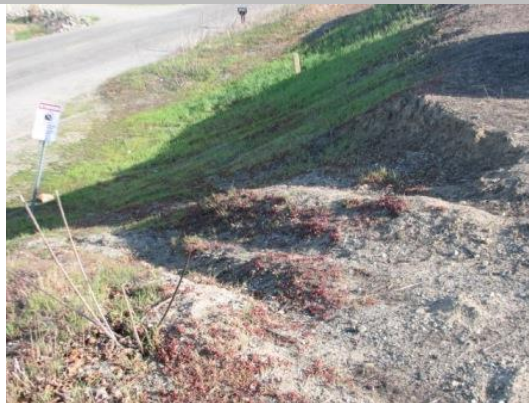
Photo 1 of 2 : SP_2016_RD1600_191_4_20160304_00004.jpg

LM Start	1.39	Rating **	M	Issue No.	4
LM End	1.39	Issue Type +	Ma	Location *	LS
Category	Earthen Levee			GPS Latitude/Longitude	
				Start	End
Item	Slope Stability			38.694395 °	38.694395 °
				-121.634376 °	-121.634376 °
DWR ID	DWR_RD1600_01_f_2012_4				
Comment Code					
S3 : Repair the levee slope damaged by vehicle traffic and prevent access where possible.					
Inspector Comment					
Damage looks like caused by vehicles.

Erosion from vehicles on levee slope. Spring 2013

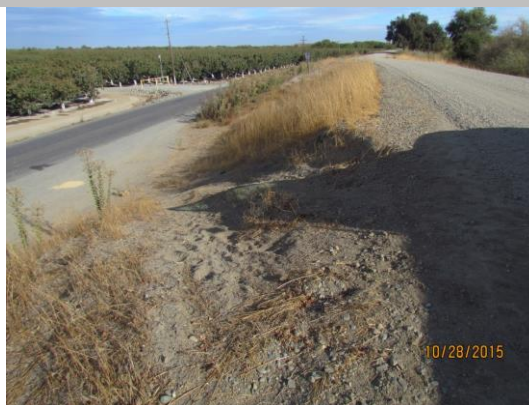
Photo 2 of 2 : SP_2016_RD1600_191_4_20160304_00005.jpg

View of the slope stability caused by vehicles on the landward side of the levee looking upstream. Fall 2015.

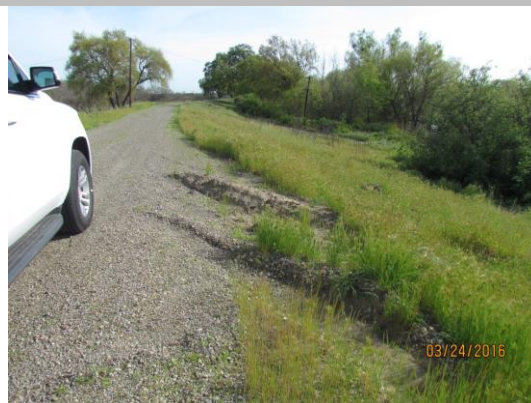
Photo 1 of 1 : SP_2016_RD1600_191_71_20160407_00111.jpg

LM Start	1.72	Rating **	M	Issue No.	71
LM End	1.72	Issue Type +	Ma	Location *	WS
Category	Earthen Levee			GPS Latitude/Longitude	
				Start	End
Item	Slope Stability			38.698628 °	38.698628 °
				-121.631694 °	-121.631694 °
DWR ID	DWR_RD1600_01_s _ 2016_71				
Comment Code					
S3 : Repair the levee slope damaged by vehicle traffic and prevent access where possible.					
Inspector Comment

View of the ruts on the shoulder of the levee on the waterward side.
Spring 2016.

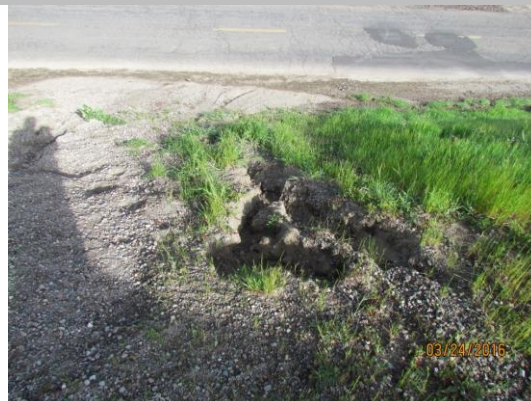
Photo 1 of 2 : SP_2016_RD1600_191_72_20160407_00113.jpg

LM Start	2.01	Rating **	U	Issue No.	72
LM End	2.01	Issue Type +	Ma	Location *	LS
Category	Earthen Levee			GPS Latitude/Longitude	
				Start	End
Item	Erosion / Bank Caving			38.701605 °	38.701605 °
				-121.627954 °	-121.627954 °
DWR ID	DWR_RD1600_01_s_2016_72				
Comment Code					
E2 : Schedule repair of erosion site prior to the next inspection.					
Inspector Comment					
Erosion seems to be caused by rain runoffs. Slope is graveled. Unsure if it is being used as a ramp.

Erosion is on the landward side of the levee about midway from the shoulder of the levee. Spring 2016.

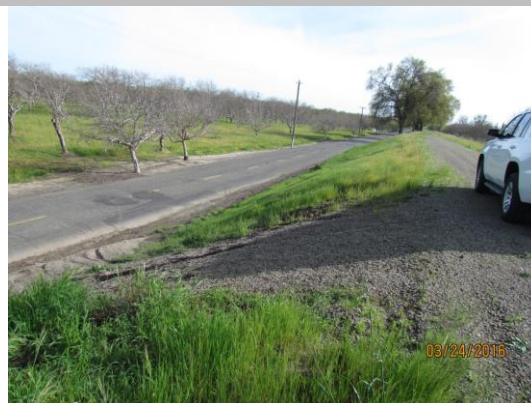
Photo 2 of 2 : SP_2016_RD1600_191_72_20160407_00114.jpg

Perspective view of the erosion on the landward side of the levee looking upstream. Spring 2016.

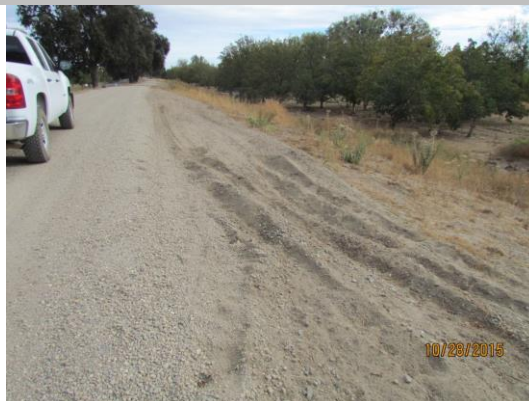
Photo 1 of 1 : SP_2016_RD1600_191_52_20160304_00044.jpg

LM Start	2.02	Rating **	M	Issue No.	52
LM End	2.02	Issue Type +	Ma	Location *	WS
Category	Earthen Levee			GPS Latitude/Longitude	
				Start	End
Item	Slope Stability			38.701753 °	38.701753 °
				-121.627734 °	-121.627734 °
DWR ID	DWR_RD1600_01_f_2015_52				
Comment Code					
S3 : Repair the levee slope damaged by vehicle traffic and prevent access where possible.					
Inspector Comment

View of the slope stability caused by vehicles on the waterward side of the levee looking upstream. Fall 2015.

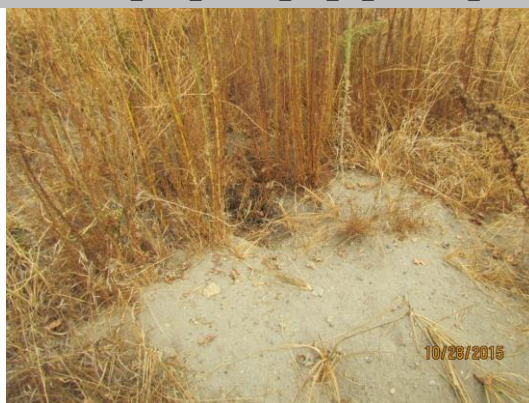
Photo 1 of 1 : SP_2016_RD1600_191_53_20160304_00045.jpg

View of the rodent hole on the waterward side of the levee. Fall 2015.

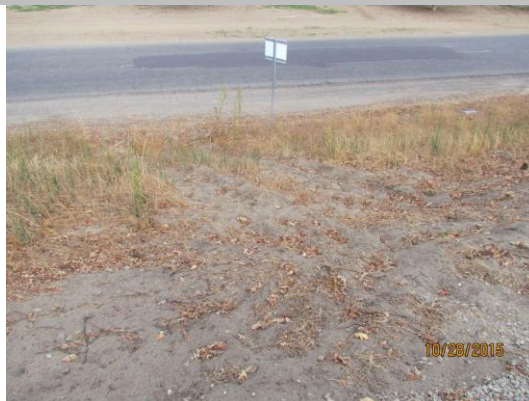
Photo 1 of 1 : SP_2016_RD1600_191_55_20160304_00047.jpg

LM Start	2.10	Rating **	M	Issue No.	55
LM End	2.10	Issue Type +	Ma	Location *	LS
Category	Earthen Levee			GPS Latitude/Longitude	
				Start	End
Item	Slope Stability			38.702416 °	38.702416 °
				-121.626593 °	-121.626593 °
DWR ID	DWR_RD1600_01_f_2015_55				
Comment Code					
S3 : Repair the levee slope damaged by vehicle traffic and prevent access where possible.					
Inspector Comment

View of the slope stability damaged by vehicles on the landward side of the levee. Fall 2015.

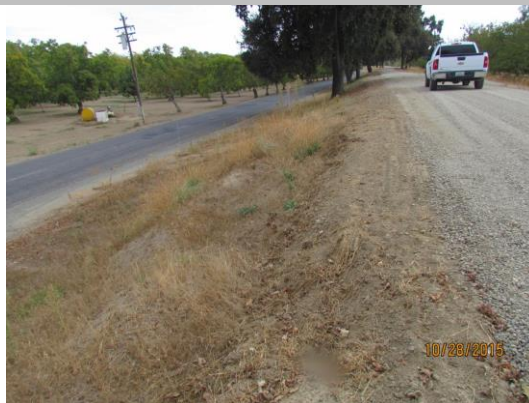
Photo 1 of 1 : SP_2016_RD1600_191_56_20160304_00048.jpg

LM Start	2.17	Rating **	M	Issue No.	56
LM End	2.17	Issue Type +	Ma	Location *	LS
Category	Earthen Levee			GPS Latitude/Longitude	
				Start	End
Item	Slope Stability			38.703025 °	38.703025 °
				-121.625605 °	-121.625605 °
DWR ID	DWR_RD1600_01_f_2015_56				
Comment Code					
S1 : Repair slope instability.					
Inspector Comment

View of the sloughing on the landward side of the levee looking upstream. Fall 2015.

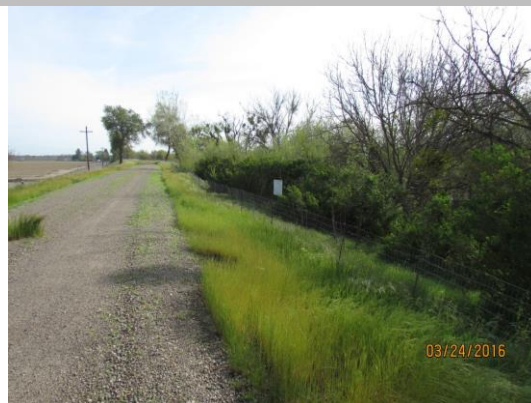
Photo 2 of 2 : SP_2016_RD1600_191_35_20160407_00115.jpg

View of the revegetation site on the waterward side of the levee looking upstream. Spring 2016.

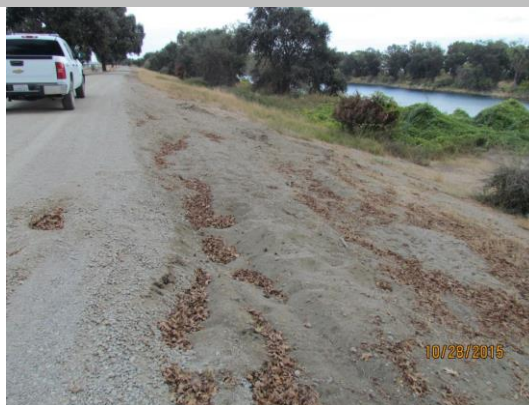
Photo 1 of 1 : SP_2016_RD1600_191_67_20160304_00053.jpg

LM Start	3.89	Rating **	M	Issue No.	67
LM End	3.89	Issue Type +	Ma	Location *	WS
Category	Earthen Levee			GPS Latitude/Longitude	
				Start	End
Item	Slope Stability			38.722300 °	38.722300 °
				-121.606769 °	-121.606769 °
DWR ID	DWR_RD1600_01_f_2015_67				
Comment Code					
S3 : Repair the levee slope damaged by vehicle traffic and prevent access where possible.					
Inspector Comment

View of the shoulder damaged by vehicles on the waterward side of the levee looking upstream. Fall 2015.

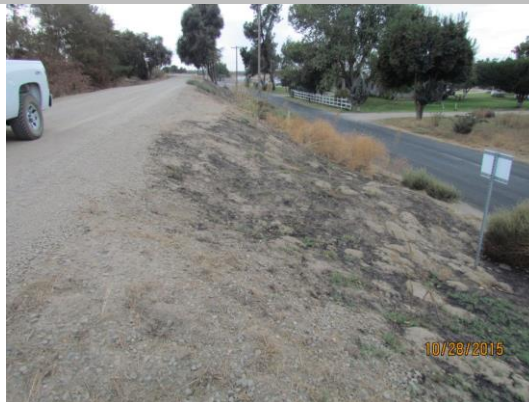
Photo 1 of 1 : SP_2016_RD1600_191_41_20160304_00036.jpg

LM Start	4.66	Rating **	M	Issue No.	41
LM End	4.66	Issue Type +	Ma	Location *	LS
Category	Earthen Levee			GPS Latitude/Longitude	
				Start	End
Item	Slope Stability			38.733294 °	38.733294 °
				-121.605484 °	-121.605484 °
DWR ID	DWR_RD1600_01_f_2015_41				
Comment Code					
S1 : Repair slope instability.					
Inspector Comment

View of the bulge at the toe of the levee on the landward side looking downstream. Fall 2015.

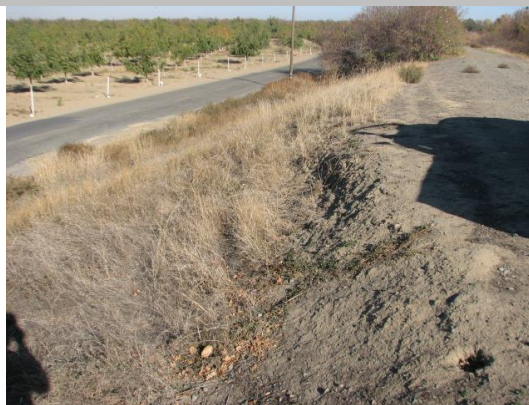
Photo 1 of 2 : SP_2016_RD1600_191_141_20160304_00058.jpg

LM Start	4.77	Rating **	M	Issue No.	141
LM End	4.77	Issue Type +	Ma	Location *	LS
Category	Earthen Levee			GPS Latitude/Longitude	
				Start	End
Item	Slope Stability			38.734840 °	38.734840 °
				-121.605026 °	-121.605026 °
DWR ID	DWR_RD1600_01_f_2013_141				
Comment Code					
S1 : Repair slope instability.					
Inspector Comment

The erosion at the shoulder of the levee could be slope instability. Fall 2013

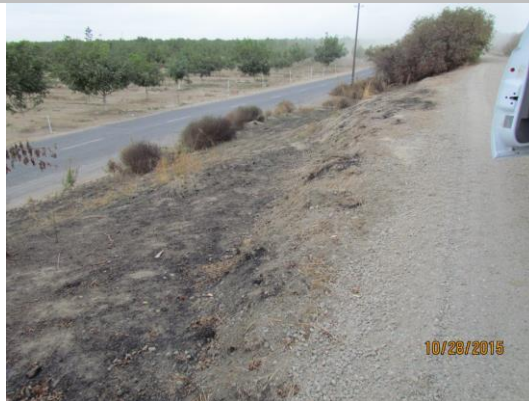
Photo 2 of 2 : SP_2016_RD1600_191_141_20160304_00059.jpg

LM Start	4.77	Rating **	M	Issue No.	141 (cont)	
LM End	4.77	Issue Type +	Ma	Location *	LS	
Category	Earthen Levee			GPS Latitude/Longitude		
				Start		End
Item	Slope Stability			38.734840 °		38.734840 °
				-121.605026 °		-121.605026 °
DWR ID	DWR_RD1600_01_f_2013_141					
Comment Code						
S1 : Repair slope instability.						
Inspector Comment

View of the erosion on the landward side of the levee looking upstream.
Fall 2015.

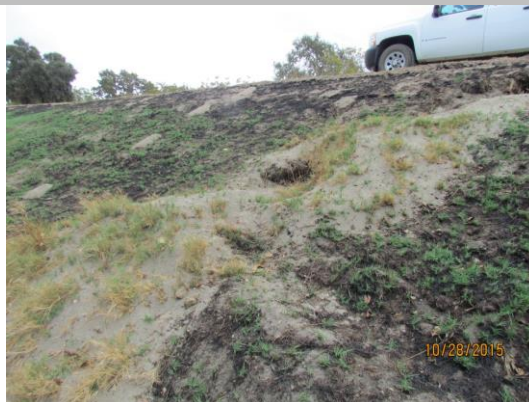
Photo 1 of 1 : SP_2016_RD1600_191_46_20160304_00040.jpg

View of the animal holes on the landward side of the levee. Fall 2015.

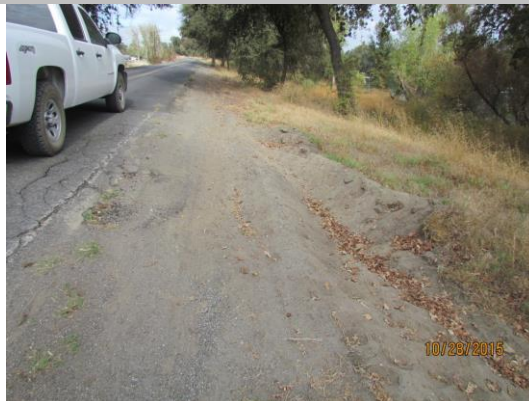
Photo 1 of 1 : SP_2016_RD1600_191_58_20160304_00049.jpg

View of the slope stability on the waterward side of the levee looking upstream. Fall 2015.

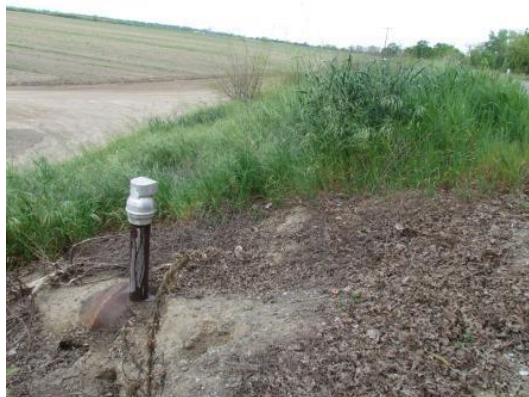
Photo 1 of 1 : SP_2016_RD1600_191_1199_20160304_00071.jpg

View of erosion and pipe on the landward side of the levee looking upstream. Spring 2015.

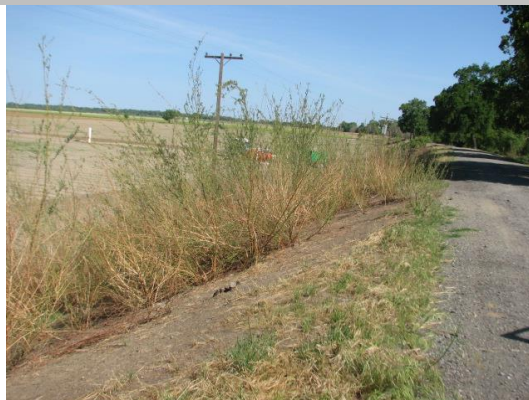
Photo 1 of 2 : SP_2016_RD1600_191_631_20160304_00066.jpg

The tall brush and vegetation blocks visibility. Spring 2014

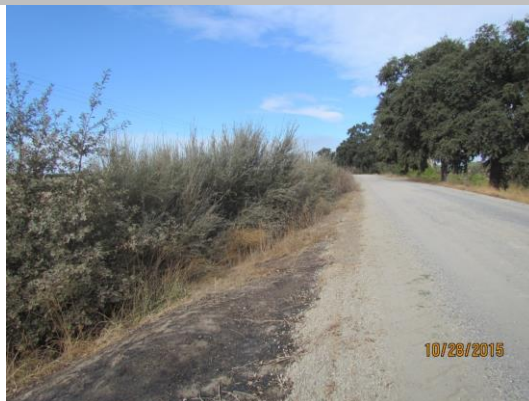
Photo 2 of 2 : SP_2016_RD1600_191_631_20160304_00067.jpg

View of the brush and vegetation on the landward side of the levee. Fall 2015.

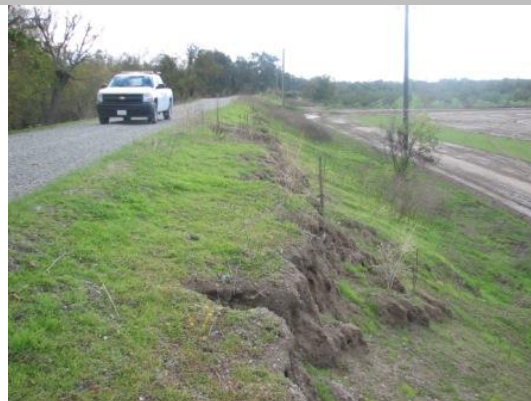
Photo 1 of 2 : SP_2016_RD1600_191_27_20160304_00022.jpg

The erosion appears to be moving closer to the shoulder.

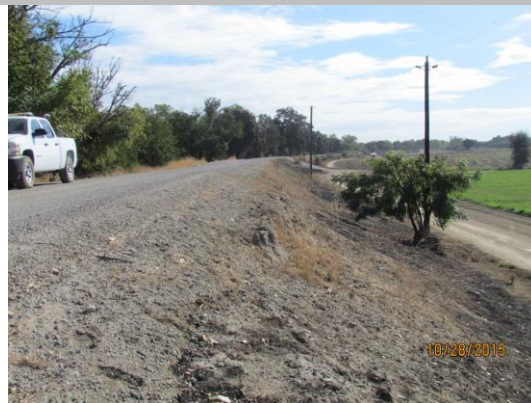
Photo 2 of 2 : SP_2016_RD1600_191_27_20160304_00023.jpg

The erosion seems to have been fixed. There still seems to be some erosion on the landward side of the levee looking downstream. Fall 2015.

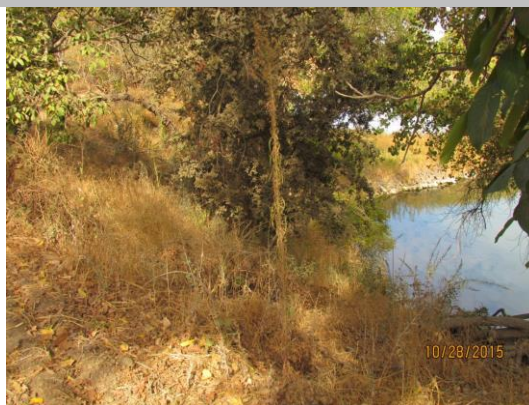
Photo 2 of 2 : SP_2016_RD1600_191_30_20160304_00027.jpg

View of the erosion into the berm area that needs to be monitored. Fall 2015.

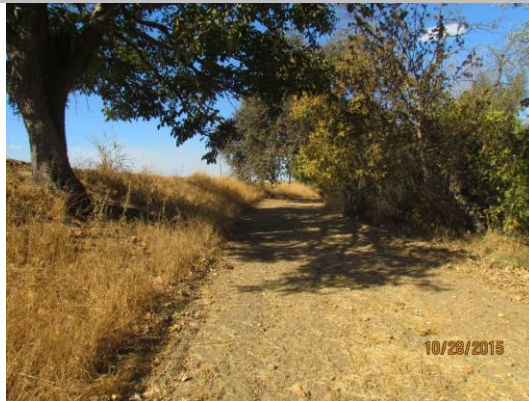
Photo 2 of 4 : SP_2016_RD1600_191_20_20160304_00014.jpg

View of the erosion in the berm area on the waterward side looking upstream. Fall 2015.

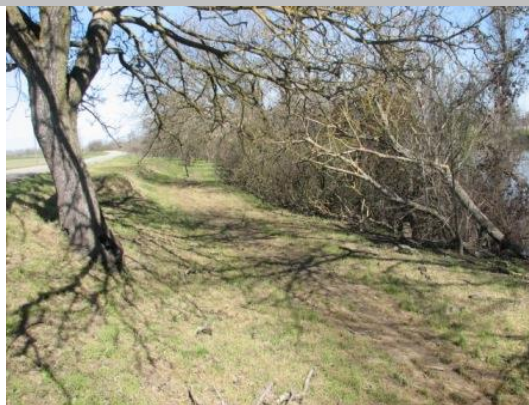
Photo 3 of 4 : SP_2016_RD1600_191_20_20160304_00015.jpg

The erosion is eroding away at the berm area.

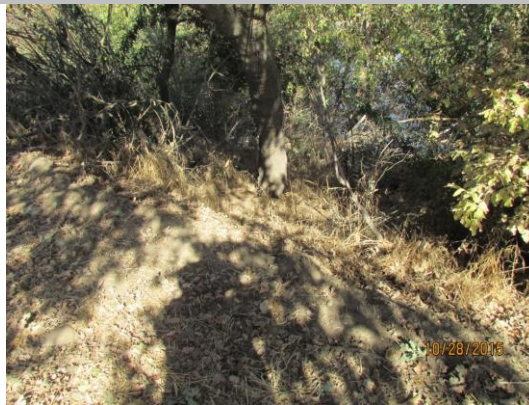
Photo 4 of 4 : SP_2016_RD1600_191_20_20160304_00016.jpg

Looking at the erosion site on the berm. Fall 2015.

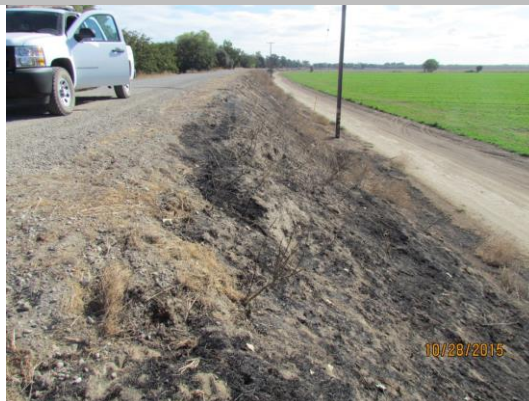
Photo 1 of 1 : SP_2016_RD1600_191_61_20160304_00050.jpg

View of the erosion on the landward side of the levee looking downstream. Fall 2015.

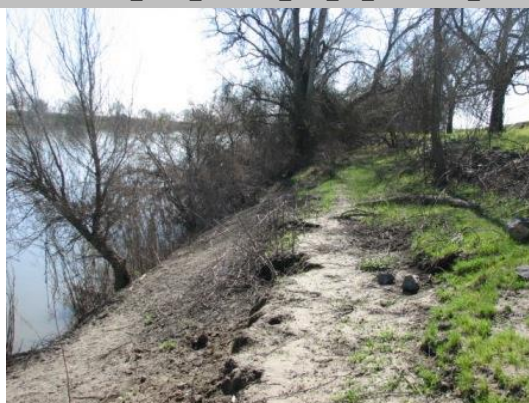
Photo 1 of 3 : SP_2016_RD1600_191_21_20160304_00017.jpg

The erosion is eroding away the berm area.

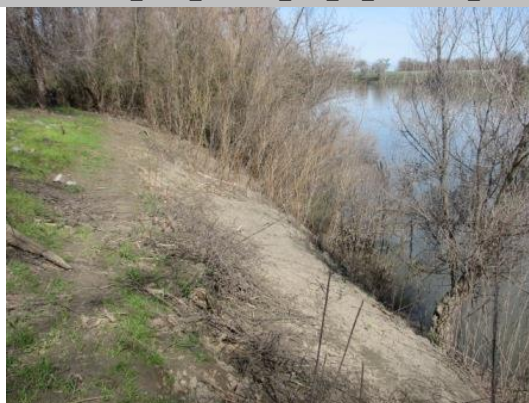
Photo 2 of 3 : SP_2016_RD1600_191_21_20160304_00018.jpg

The bank is eroding away and has become very steep.

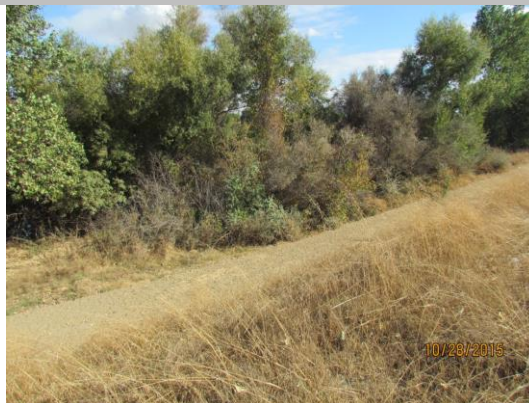
Photo 3 of 3 : SP_2016_RD1600_191_21_20160304_00019.jpg

View of the erosion along the waterward berm of the levee. Fall 2015.

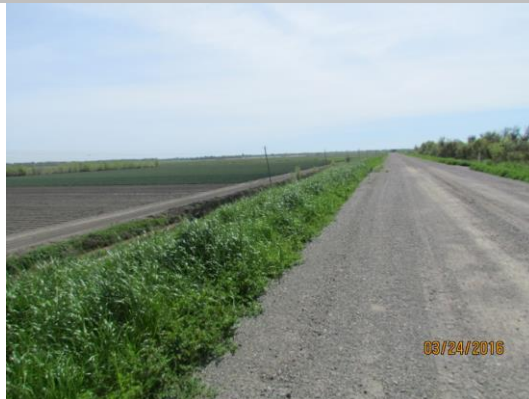
Photo 1 of 1 : SP_2016_RD1600_192_4_20160407_00012.jpg

View of the vegetation on the landward side of the levee looking downstream. Spring 2016.

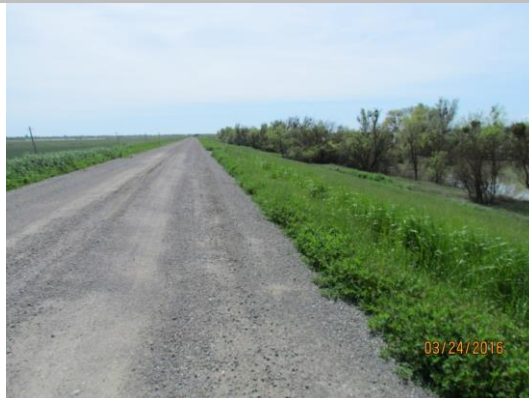
Photo 1 of 1 : SP_2016_RD1600_192_5_20160407_00013.jpg

View of the vegetation on the waterward side of the levee looking downstream. Spring 2016.

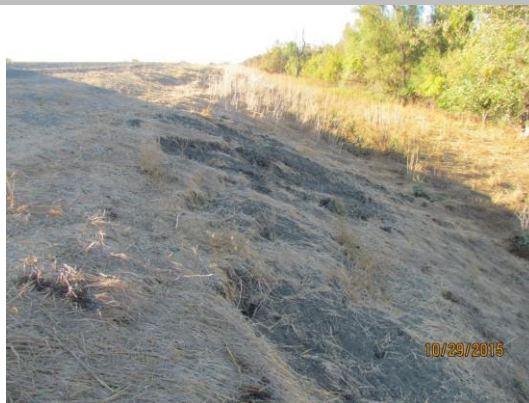
Photo 1 of 1 : SP_2016_RD1600_192_8_20160304_00003.jpg

View of the slope stability on the waterward side of the levee looking downstream. Fall 2015.

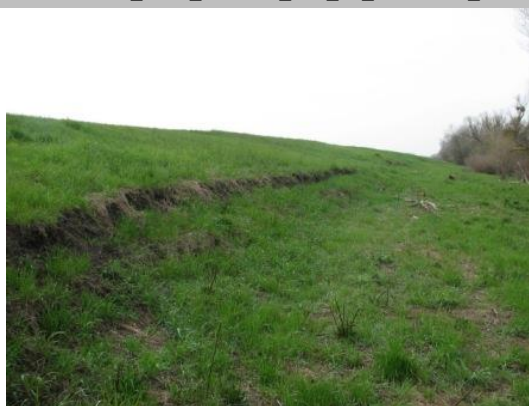
Photo 1 of 3 : SP_2016_RD1600_192_14_20160304_00005.jpg

A closer view of the wave wash damage along the bypass.

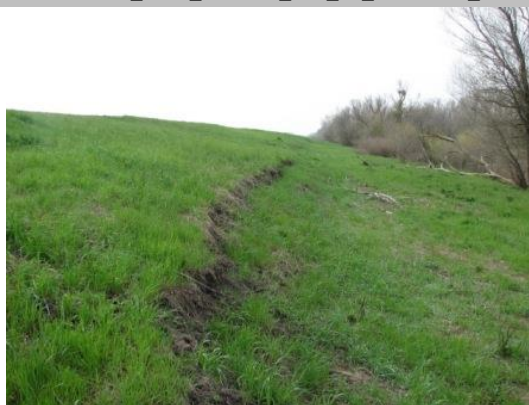
Photo 2 of 3 : SP_2016_RD1600_192_14_20160304_00006.jpg

Wave wash damage along the slope the cut is 1'-2'.

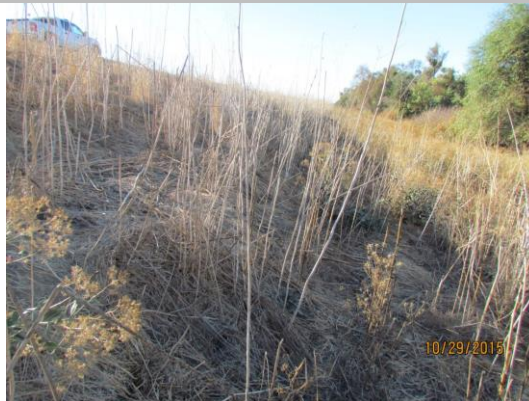
Photo 3 of 3 : SP_2016_RD1600_192_14_20160304_00007.jpg

View of the erosion on the waterward side of the levee looking downstream. Fall 2015.

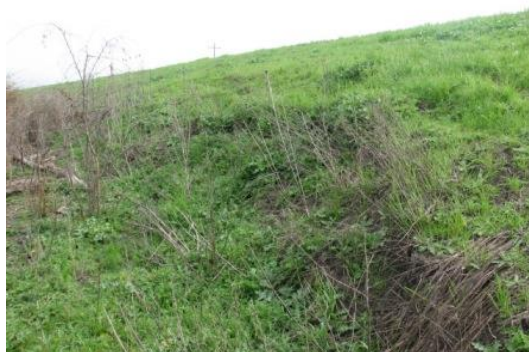
Photo 1 of 2 : SP_2016_RD1600_192_15_20160304_00008.jpg

Looking upstream a deeper cut of 2'-3' damage.

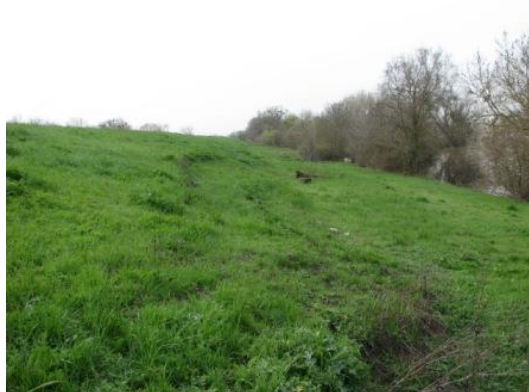
Photo 2 of 2 : SP_2016_RD1600_192_15_20160304_00009.jpg

This is wave wash damage along the toe of the levee looking downstream.
